ATTENTION

INSTALLATION OF THIS AIR SUSPENSION COMPRESSOR REQUIRES THE REPLACEMENT OF THE COMPRESSOR RELAY.

4 11-21-8695 REV 01 May 10, 2023

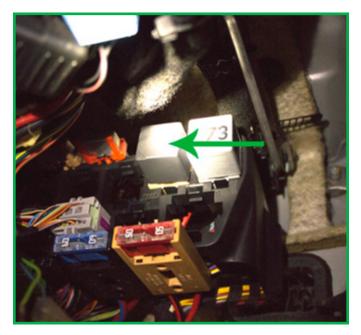
P-2134/P-3297

01-05 AUDI ALLROAD QUATTRO (C5)
Relay located on the left side of the vehicle under the dashboard.

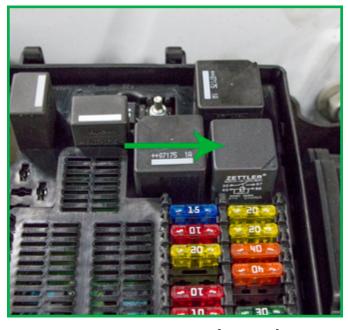
P-2291/P-3299/P-3305

04-09 JAGUAR XJ SERIES (X350/358)
Relay located on the right side of the vehicle in the engine compartment.

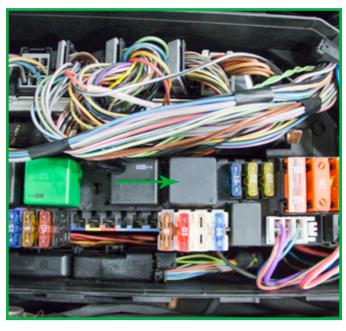
P-2192/P-3296

00-06 MERCEDES-BENZ S-CLASS
Relay located on the right side of the vehicle in the engine compartment.

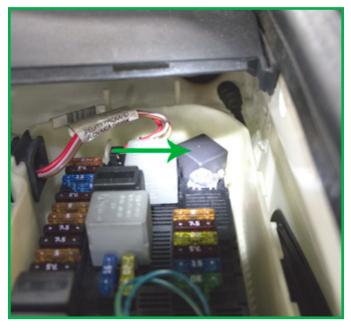
02-09 MERCEDES-BENZ E-CLASS
Relay located on the left side of the vehicle by the firewall.

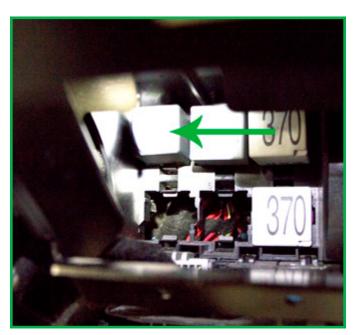
P-2539/P-2599

04-10 AUDI A8 QUATTRO (D3)Relay located on the left side of the vehicle under the dashboard.

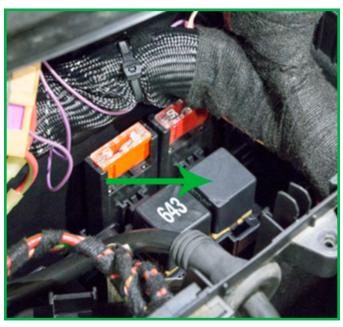
P-2984/P-3302/P-3317

05-11 AUDI A6 (C6)Relay located on the left side of the vehicle under the wiper cowl.

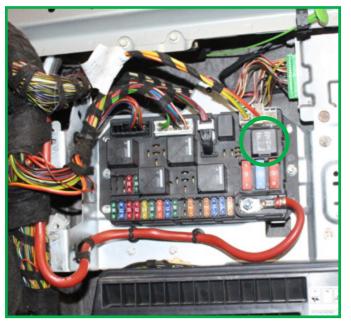
P-2462

03-05 LAND ROVER RANGE ROVER (L322) Relay located on the rear right fuse box.

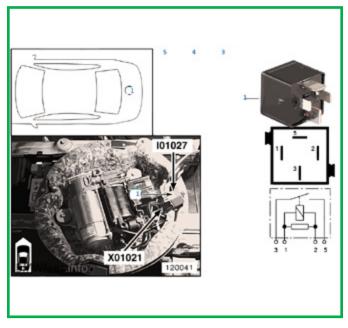
P-2494

00-06 BMW X5 (E53, W/4-CORNER LEVELING)
Relay is mounted to the compressor.

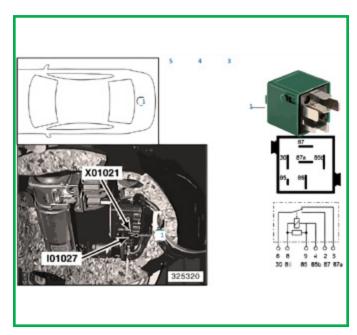
P-2469

99-03 BMW 5 SERIES (E39) Relay is mounted to the compressor.

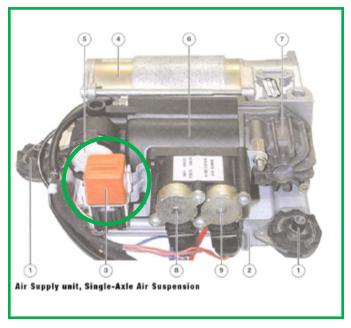
02-08 BMW 7 SERIES (E65,E66)Relay is mounted to the compressor.

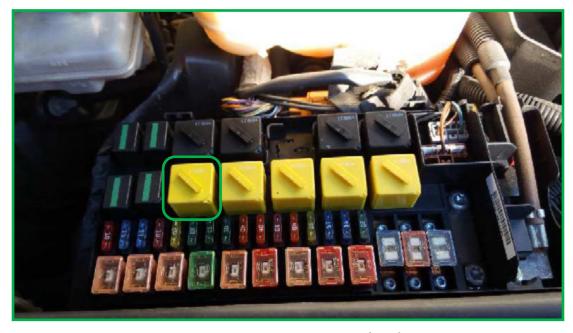
P-2495

98-04 LAND ROVER DISCOVERY II (L318) Relay located within Underhood Fuse Block.

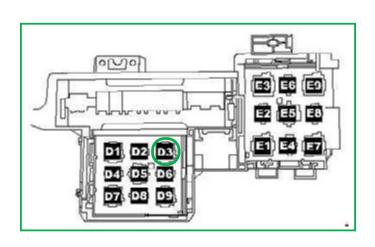
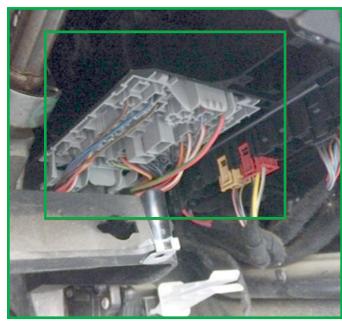
P-2496/P-3298/P-3304

04-10 VOLKSWAGEN TOUAREG (7L)
Relay located under the drivers side dashboard.

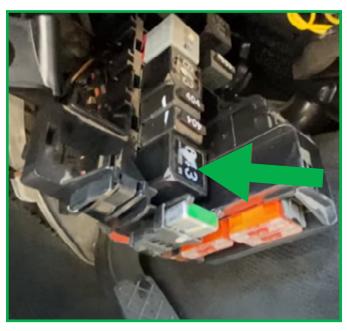
P-2496/P-3298/P-3304

07-15 AUDI Q7 (4L)Relay located under the drivers side dashboard.

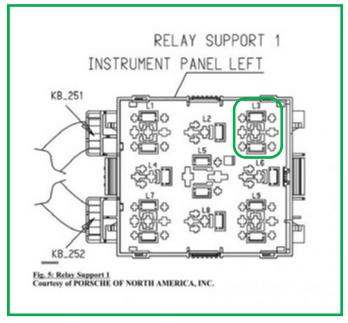
03-10 PORSCHE CAYENNE (9PA)Relay located under the drivers side dashboard (Position L3).

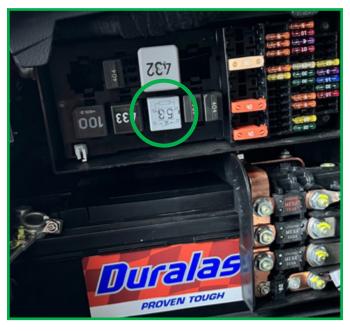
P-2740

03-19 BENTLEY CONTINENTAL GT/06-19 FLYING SPUR (D1)
Relay located in rear left of the trunk, above the battery.

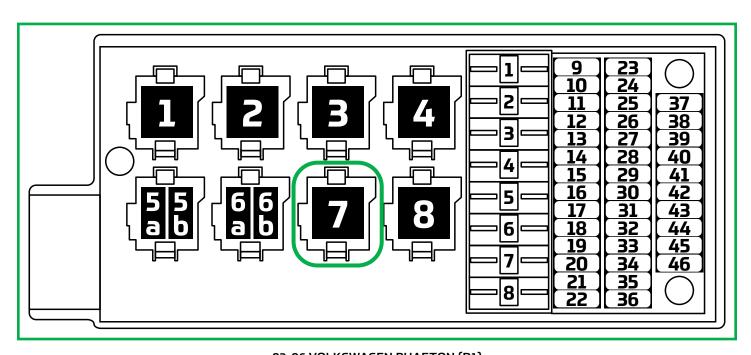
03-06 VOLKSWAGEN PHAETON (D1)
Relay located in luggage compartment on the left side.
