## **VALVE BLOCK - AIR LINE DIAGRAM**

11-17 BMW 5 SERIES GT (F07) 09-15 BMW 7 SERIES (F01/02/04) (FIGURE 1)

14-18 BMW X5 (F15) 15-19 BMW X6 (F16) (FIGURE 2)

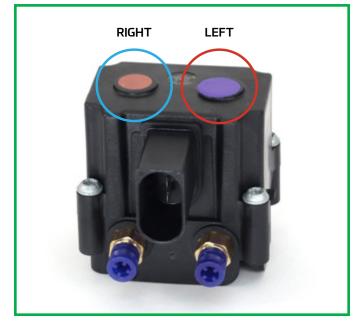
FIGURE 1 FIGURE 2

NOTE: The colored dots on the valve block match the air line colors.

**NOTE:** The colored dots on the valve block are the **opposite** of the air line colors.
