# NEW MANUFACTURED AIR STRUT SERVICE BULLETIN

W222 CHASSIS

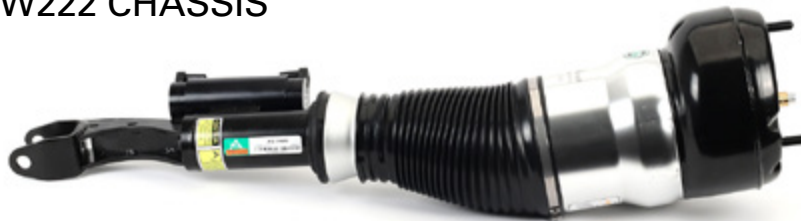
UPON VISUAL INSPECTION OF YOUR AIR STRUT, IT MAY APPEAR THAT THE AIR STRUT IS BENT. THIS IS COMPLETELY NORMAL AND THE AIR STRUT WILL STRAIGHTEN OUT WHEN PROPERLY INSTALLED ON THE VEHICLE.

THIS IS NORMAL  
(AS-3160, AS-3161)

**DO NOT RETURN AIR STRUT DUE TO THE VISUAL APPEARANCE OF IT BEING BENT.**

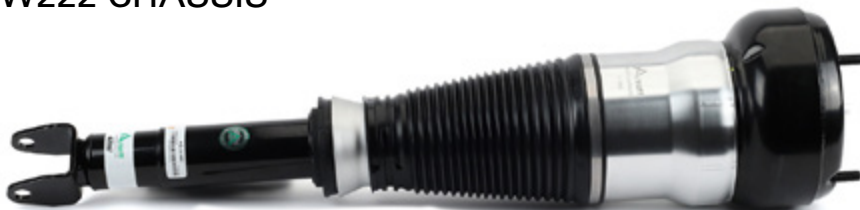
W222 CHASSIS

THIS IS NORMAL  
(AS-3162, AS-3163)
